ACOUSTIC TOMOGRAPHY

(HIGH-RESOLUTION GEOLOGICAL SURVEY)

JFE Civil Engineering and Construction Corporation

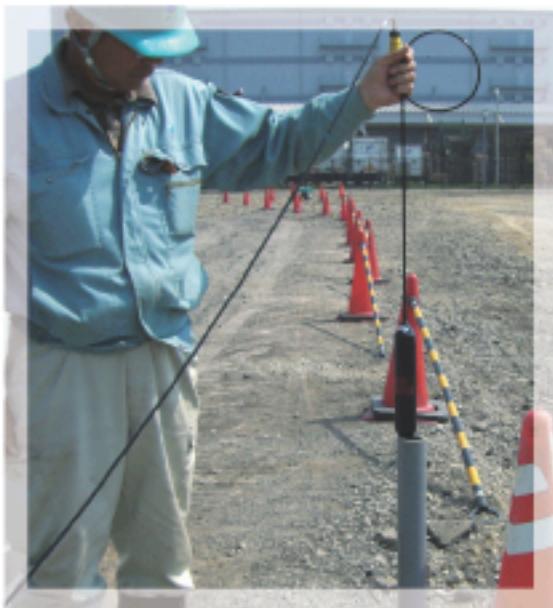
TRANSDUCER

- Piezo type
- OD=44mm, L=270mm
- Weight=4.5kg
- Frequency: 100Hz ~ 20kHz

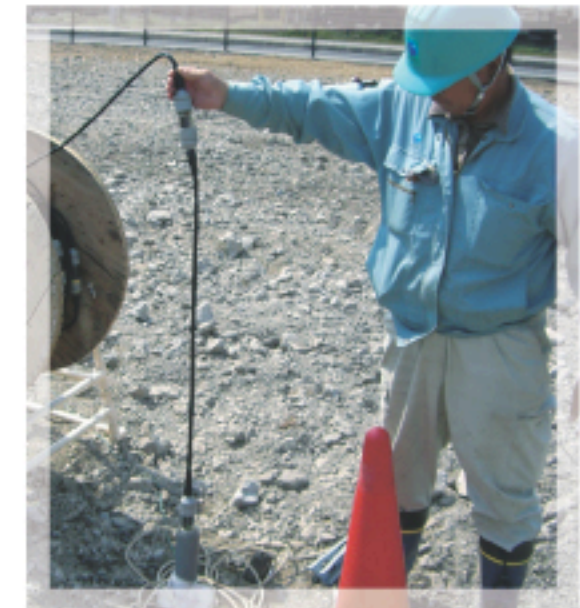
RECEIVER

- Piezo type
- OD=33mm, Weight=11kg
- 24channels@1m-interval
- Frequency: 1Hz ~ 20kHz

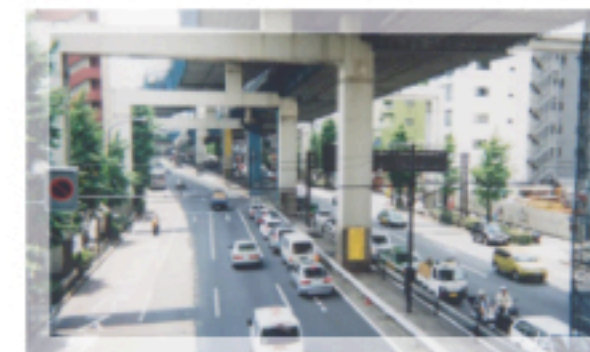
Noise Proof 03

Quite difficult to gather the clear data by the conventional seismic tomography

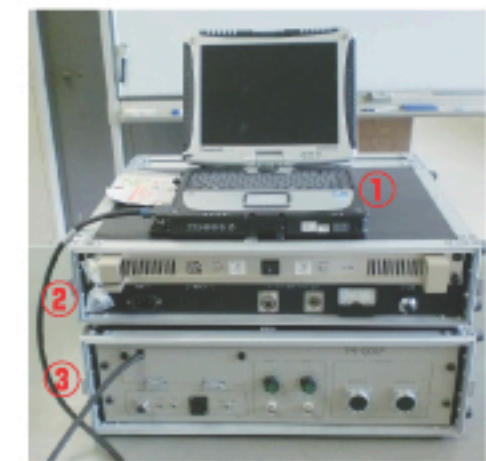
- DATA LOGGER**
 - Input: 24ch, Resolution: 14bit
- SIGNAL FILTER**
 - Input: 24ch, Gain: 100times
 - Band Pass Filter (200Hz to 60kHz)
 - AC 100V, Weight: 7kg
- POWER AMPLIFIER**
 - Output: 120V (<20kHz)
 - Frequency: 20Hz ~ 20kHz
 - AC 100V, 60W, Weight: 9kg

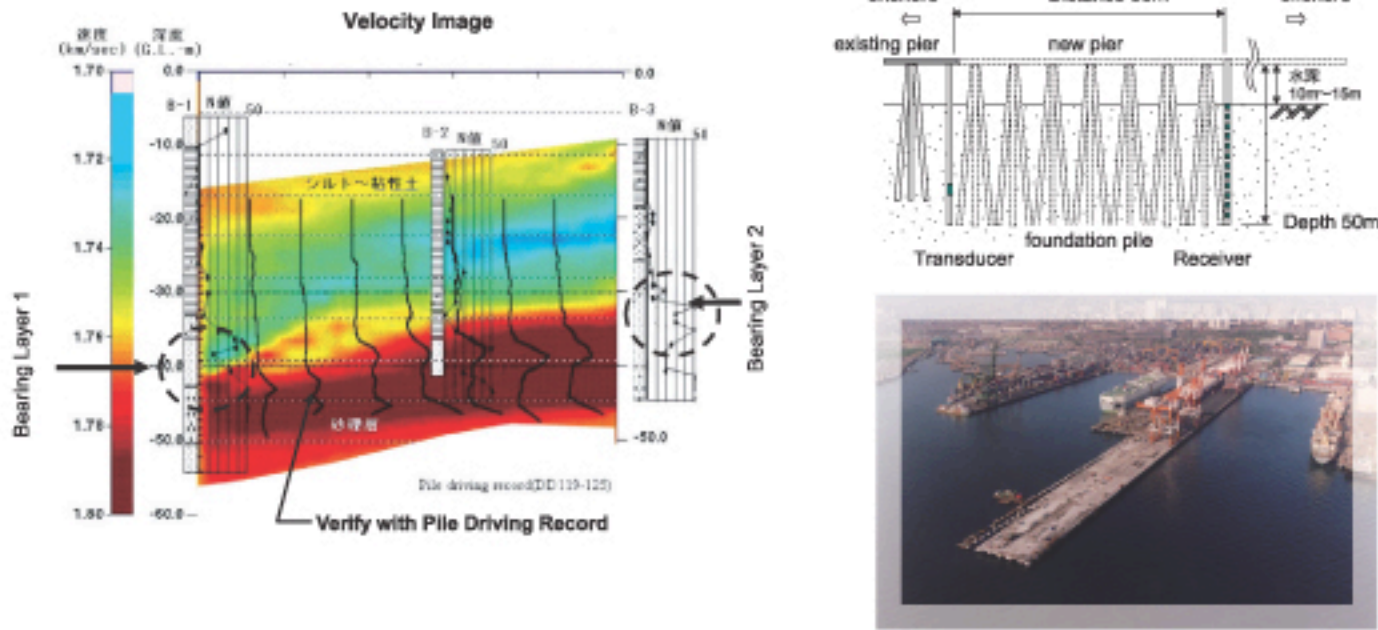
Port of Manila in Philippines Past Result

A bearing layer of the piles was different by 8m between two boring results with the distance of 50m. Acoustic tomography was conducted to investigate the bearing layer in between two borings and then successfully minimize the loss of steel pipe pile materials and the construction period.

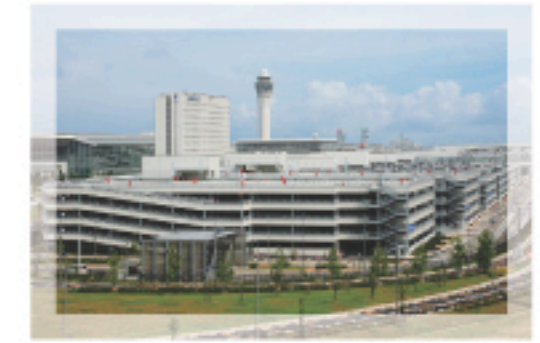
Pre-boring and PC pile installation method
[Advantage]
 No vibration or noise
[Disadvantage]
 Pile splicing and pile cutting are not allowed.

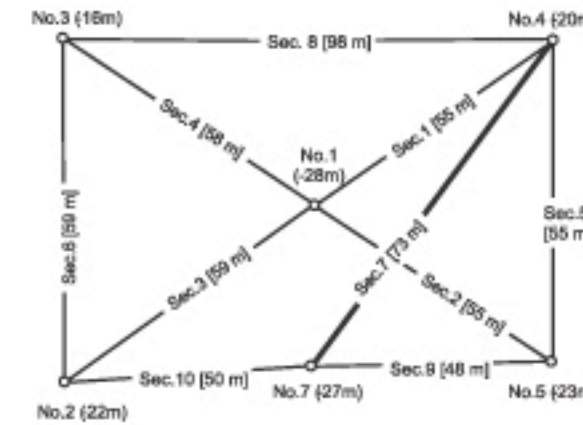
Detail investigation by Acoustic Tomography

- ✓ No. of Section: 10 cross sections
- ✓ Distance: 47.6m ~ 97.8m
- ✓ Depth: 5m ~ 39m
- ✓ Frequency: 2kHz (Resolution: less than 1m)

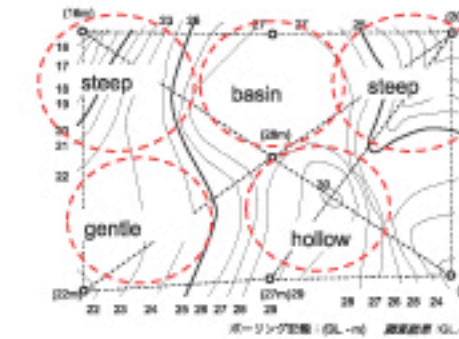
Depth contour map made from 10 sections of the tomogram

Underground structure estimated only from boring logs became simple, and difficult to reflect the actual complicated underground structure. Thanks to Acoustic Tomography conducted, the pile length was precisely designed. As a result, the multi-story-car-park was constructed on schedule without any adjustment of piles or redo-works.

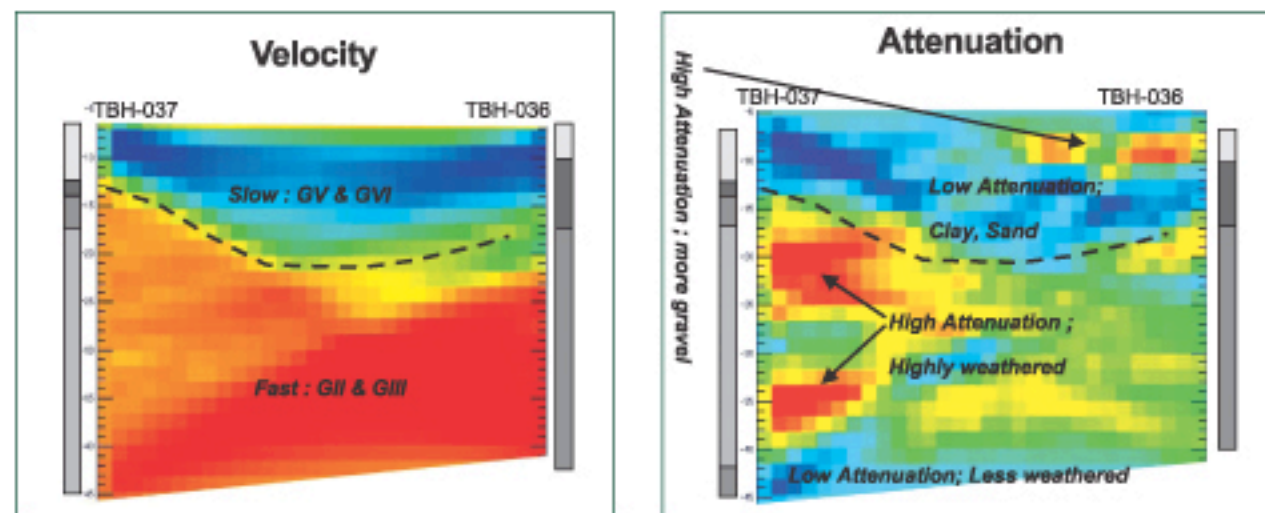
Granite in Singapore Past Result

Weathering grades of Granite are indicated in attenuation image

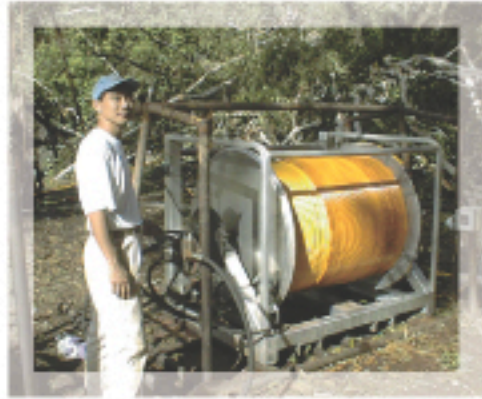
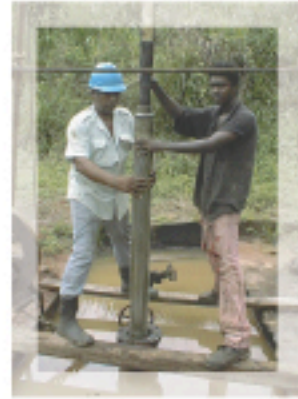
Oil Exploration Past Result

Investigate the layer with crude oil by Velocity, the gas concentrated area by Attenuation

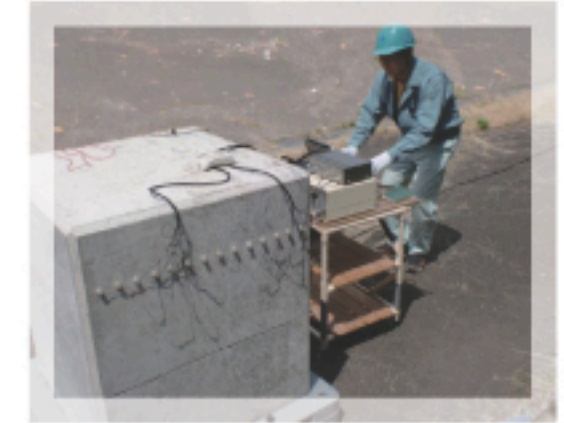
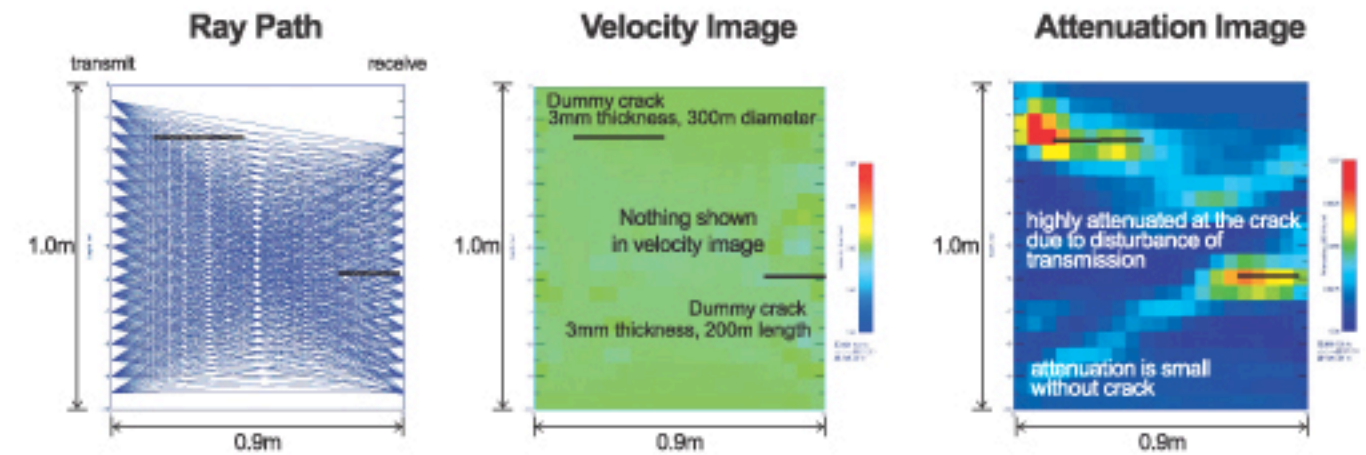
Visualize cracks and openings inside of concrete structure

- Detect inside cracks or openings as small as some cm without any influence of re-bars.
- Possible to apply for the inspection of the pier with traffic due to Noise Proof.

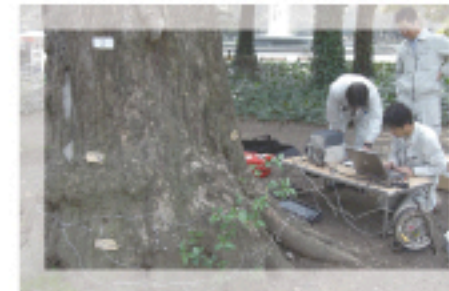
DR. WOODS Other Application

Field investigation at Hibiya Park, Tokyo

A Plane Tree : Diameter 62cm
